The Evacuation of the Chalcots Estate

An Independent Review

Prepared by
Marian Harrington
June 2018

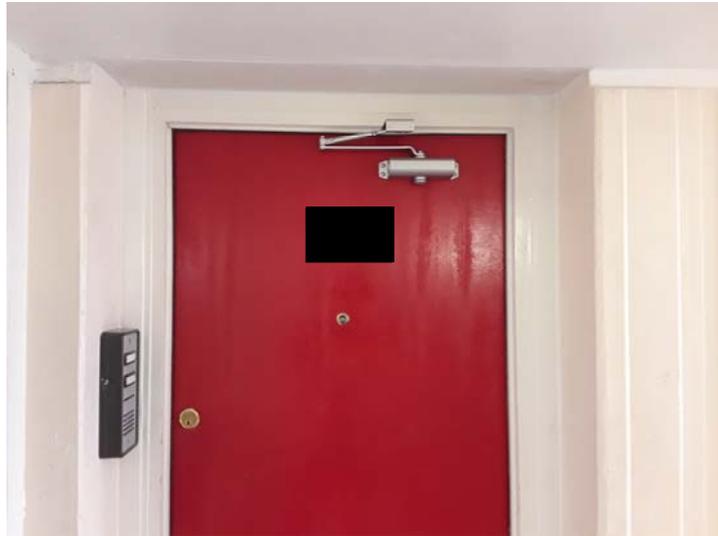
PHOTOGRAPH 1 – Typical Fire Door with Door Closure

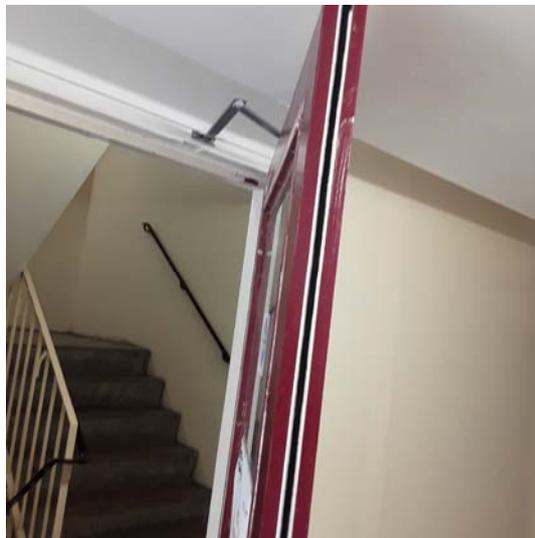
PHOTOGRAPH 2 – Typical Retrofit Intumescent Strip to Fire Door

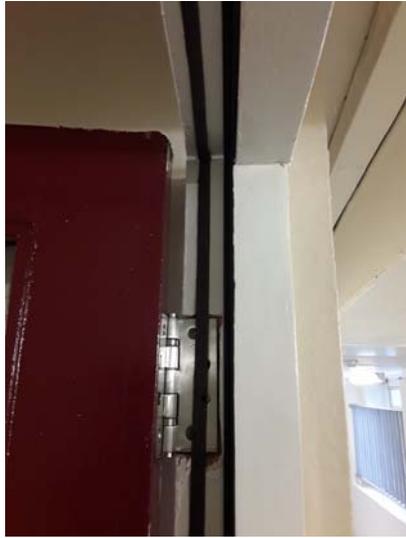
PHOTOGRAPH 3 – Typical Fire Door Hinges

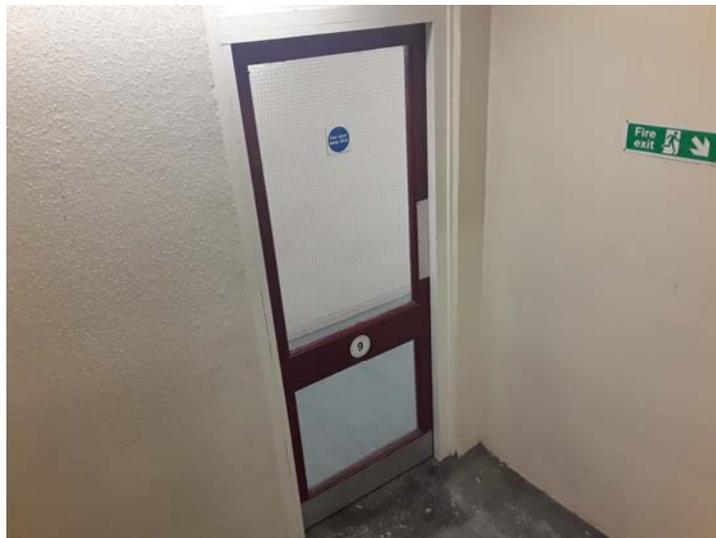
PHOTOGRAPH 4 – Typical Communal Fire Door

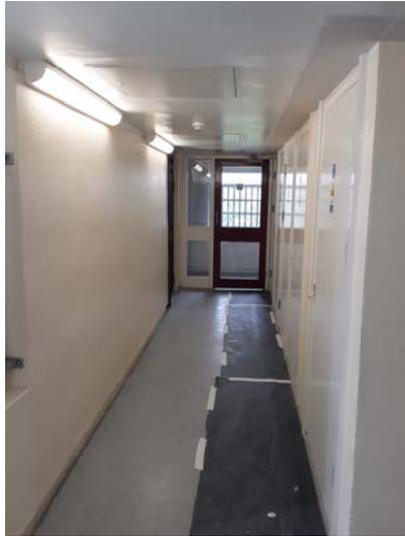
PHOTOGRAPH 5 – Typical Corridor Showing Compartmentation Works to Ceiling & Upgrade Works to Fire Doors

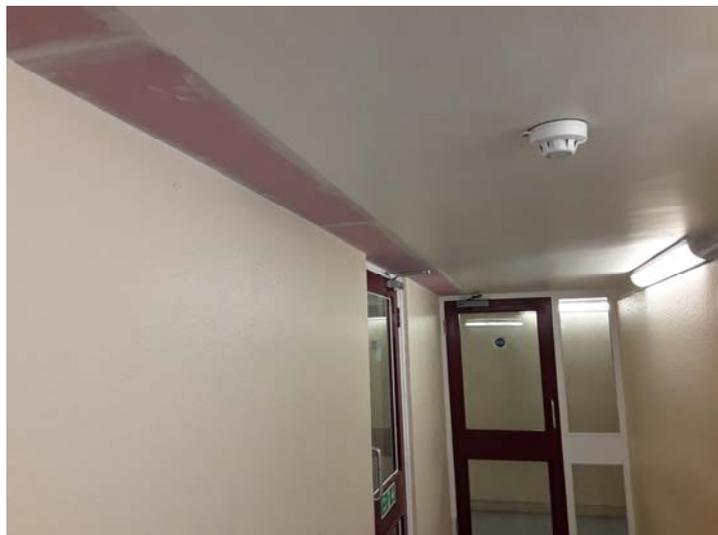
PHOTOGRAPH 6 – New 60 Minute Compartmentation to Ceilings

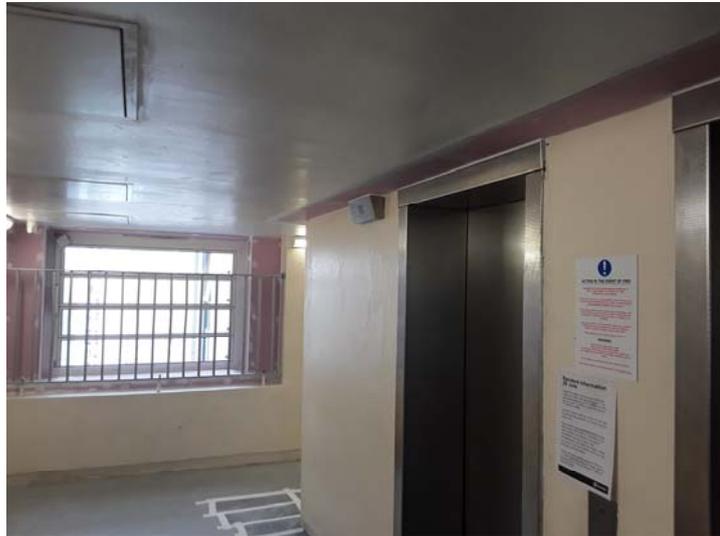
PHOTOGRAPH 7 – New 60 Minute Compartmentation to Ceilings & to Window Surrounds

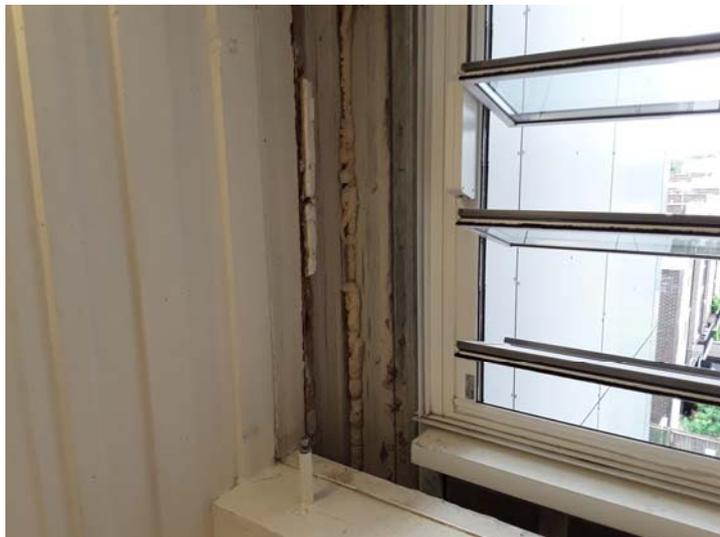
PHOTOGRAPH 8 – Existing Surrounds to Communal Windows

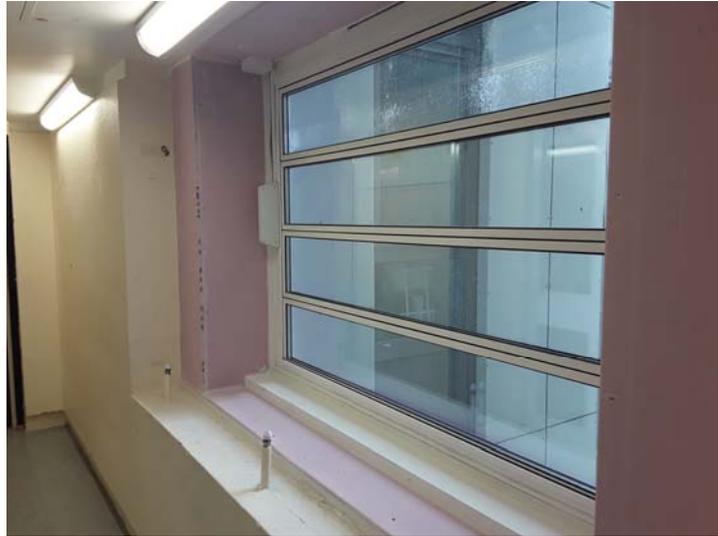
PHOTOGRAPH 9 – Compartmentation Works to Window Surround & AOV Mechanism

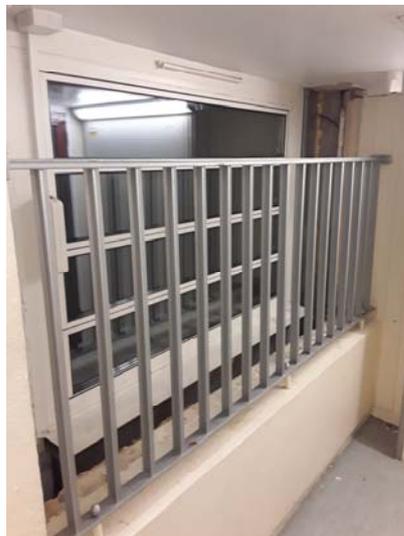
PHOTOGRAPH 10 – Typical Communal Window with AOV

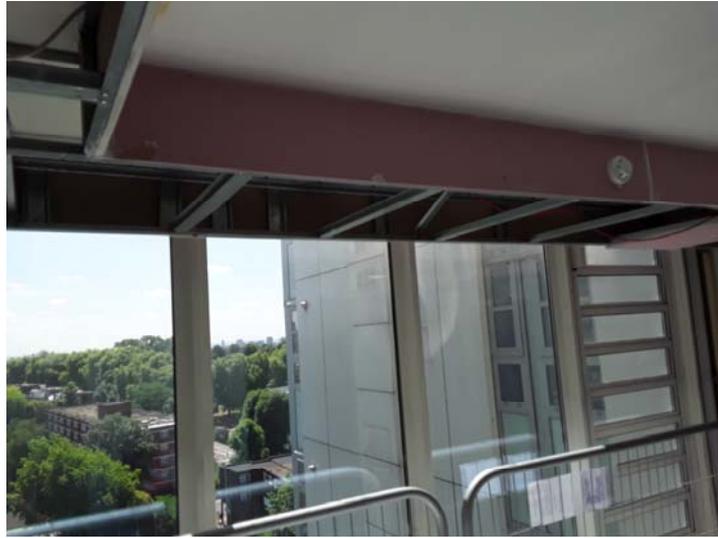
PHOTOGRAPH 11 – Typical Mestec Frame Supporting 60 Minute Fire Compartmentation Plasterboard

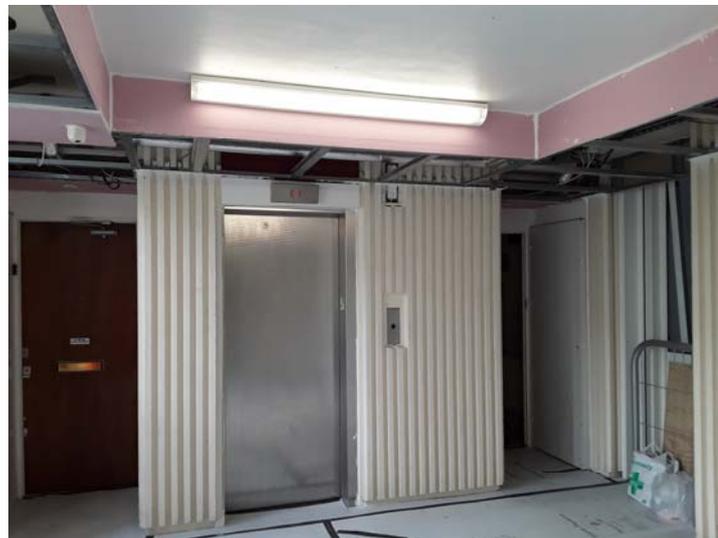
PHOTOGRAPH 12 – Compartmentation Works to Lift Lobby Areas

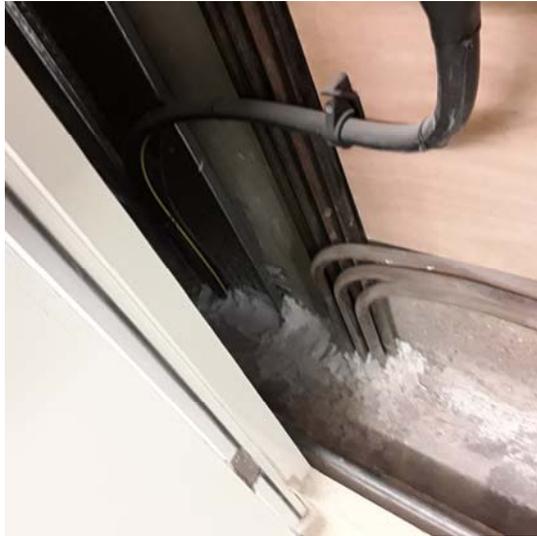
PHOTOGRAPH 13 – Fire Proofing to Service Penetrations

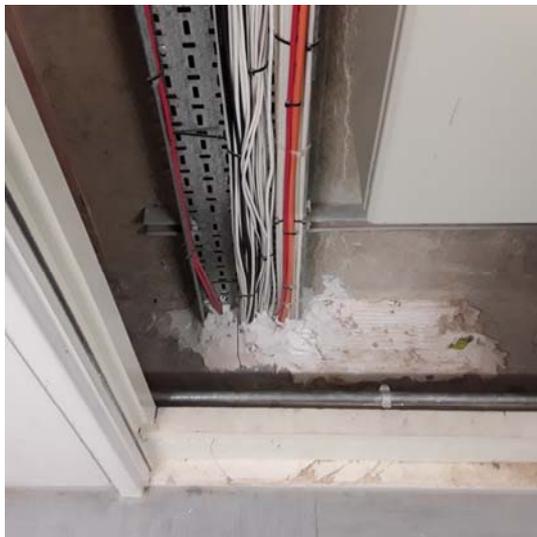
PHOTOGRAPH 14 – Fire Proofing to Service Penetrations
