# London Borough of Camden Section 19 Flood Investigation Report

Flood Incidents on the 12<sup>th</sup> and 25<sup>th</sup> July 2021

Project number: 60672596

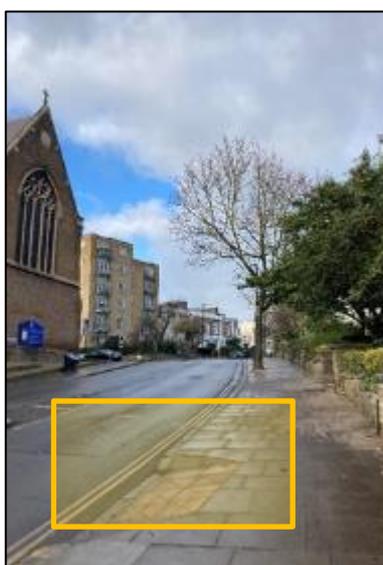
Photograph 2

The kerb height along Dartmouth Park Hill varies, to allow for pedestrian and vehicle access; this is presented in **Photograph 2**. Low kerb heights could enable the transfer of water onto the footpath, during periods of high rainfall. As highlighted in **Photograph 3**, there are several speed bumps located on the road, which may direct and channel surface water on the road, to increase the speed of flow.

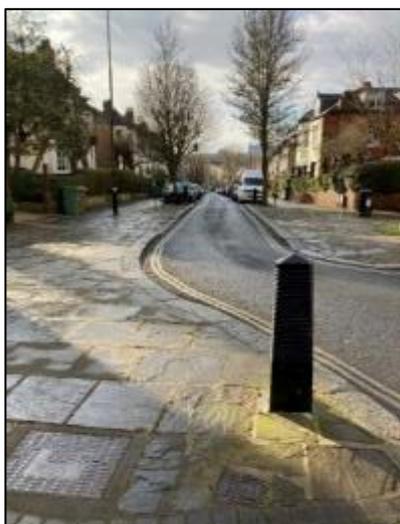
Photograph 4

Although the road is narrow, it is bordered by parking spaces on both sides, creating a large impermeable surface area. As presented in **Photograph 4**, the footpath adjacent to the road is wide and greenspace is limited. The capacity for infiltration is therefore low, increasing the volume of surface water which may be conveyed to the lower elevations and the risk of ponding.

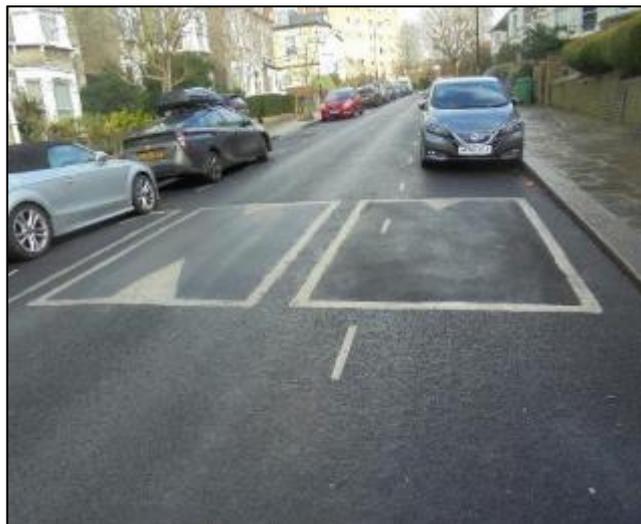
Photograph 5

As presented in **Photograph 5**, several speed bumps are located on Dartmouth Park Road. The raised bumps are separated, creating narrow channels which can direct surface water flows to the side of the road. By channelling the flow, the speed bumps may increase the water level and result in the kerb height being exceeded. This could lead to ponding on the footpath and conveyance toward property thresholds.

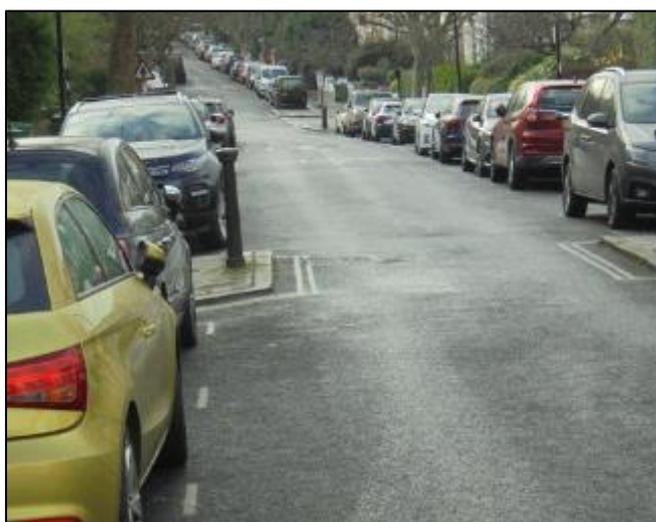
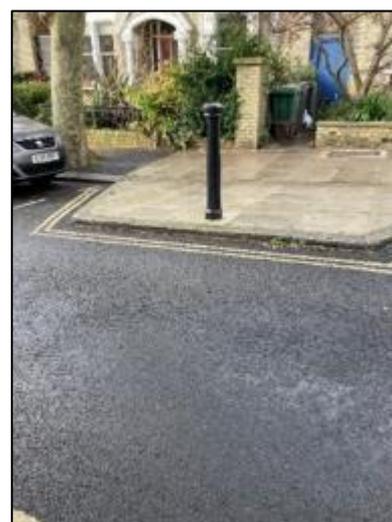
Several sections of the road are divided by small areas of pavement, which are raised above the road surface; this is presented in **Photograph 6** and **Photograph 7**. The pavement is likely to intercept flows, directing surface water to the side of the road. This may result in transfer of water to the footpath and to nearby property. At these locations, the height of the kerb is typically <100mm and, during a high intensity rainfall event, could be exceeded.

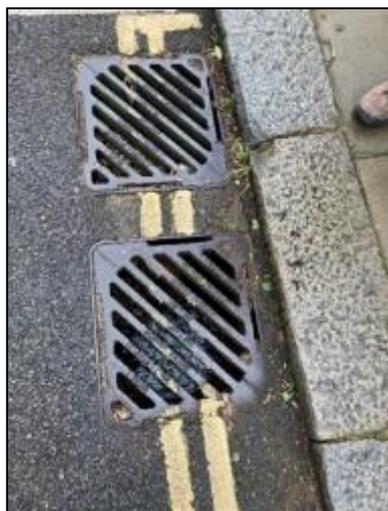
Photograph 8

York Rise is situated in an area of low elevation and is west of steep roads, such as Dartmouth Park Road. For this reason, surface water flows are conveyed toward York Rise, from several pathways. During the site visit, the drains contained a high volume leaves and debris, which indicate the presence of flows to York Rise; this is presented in **Photograph 8**.

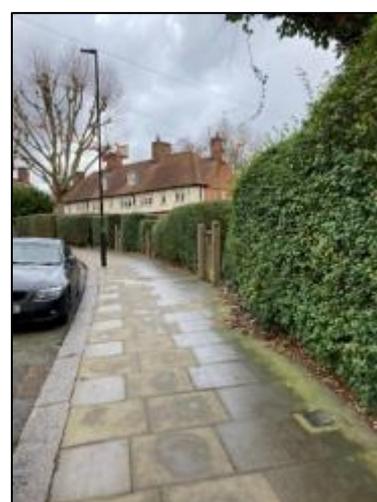
Photograph 11

As presented in **Photograph 11**, the width of Croftdown Road and adjacent footpath creates a large impermeable surface, which may reduce the capacity for infiltration of surface water, during high intensity rainfall events. The greenspace provided by private gardens is limited, relative to the total area of the road. When considered alongside the topography of the road, it is likely that high volumes of surface water are conveyed to the lower elevations, such as York Rise.

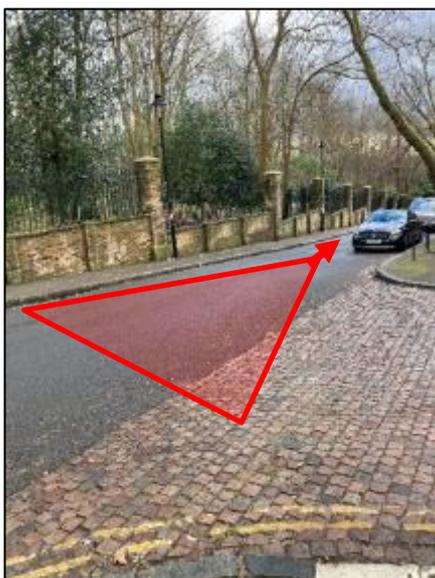
Photograph 12

As presented in **Photograph 12**, the topography of Swain's Lane is steep, with a decline in slope to the south. This is likely to increase the rate and volume of surface water conveyed on Swain's Lane, to areas of lower elevation. Roads such as York Rise and Croftdown Road are located south of Swain's Lane and in an area of lower elevation. The extensive road network may facilitate conveyance of flows to York Rise and Croftdown Road, resulting in greater volumes of surface water at these locations.

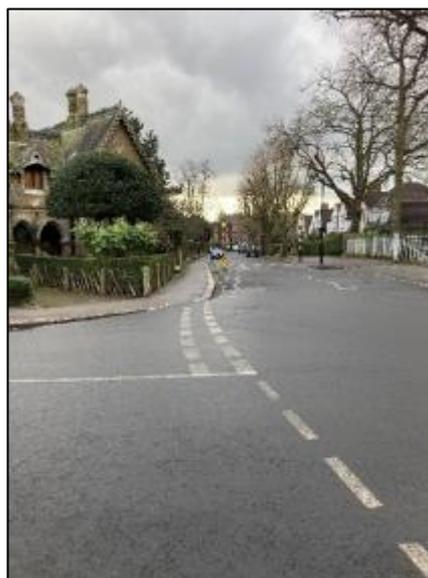
Photograph 13

Although there is some capacity for infiltration, due to private gardens and the cemetery located immediately east it is likely that large volumes of surface water are conveyed downslope, due to the large impermeable surface area provided by Swain's Lane. As presented in **Photograph 13** the road is wide, which increases potential for flow conveyance.

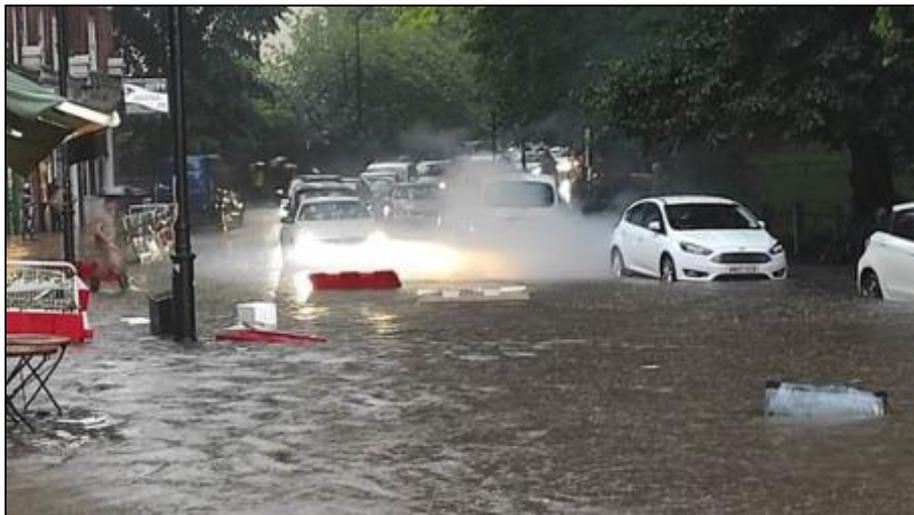
**Photograph 15**

- As presented in **Photograph 15**<sup>20</sup> and **Photograph 16**<sup>21</sup>, South End Road was flooded on the 12<sup>th</sup> and 25<sup>th</sup>, respectively. The high level of disruption is clear from photographic evidence of both events, which shows queuing traffic and debris in the road;

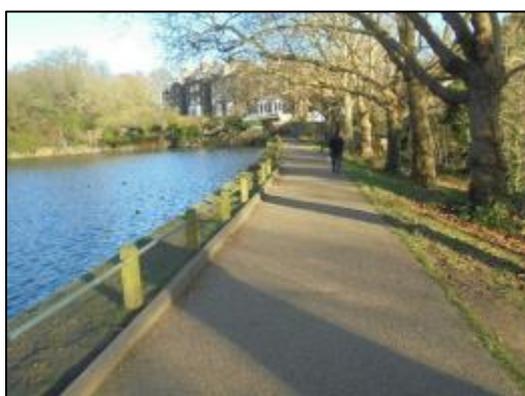
**Photograph 17**

As presented in **Photograph 17**, the pond chain is separated by artificial dams and public footpaths; this provides structural security and allows for pedestrian access to other areas of Hampstead Heath. Records of the Ponds Project indicate the outfall of Hampstead Number 2 is located in the south west corner, which outflows to the north west corner of Hampstead Number 1<sup>22</sup>. Records from TW indicate the outfall of Hampstead Pond Number 1 discharges to the combined sewer network, located at Ordnance Survey National Grid Reference (OS NGR) TQ 27179 85811 on South End Road. As presented in **Photograph 18**, structures such as trash screens are used to maintain the condition of the pond.

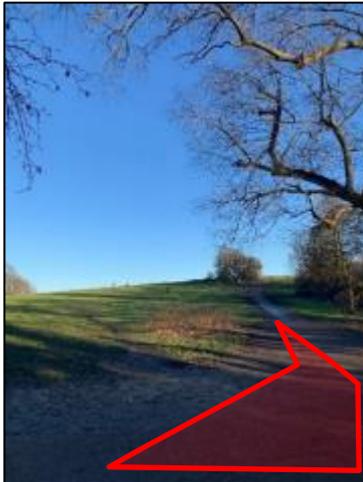
Photograph 19

East of the Hampstead Pond chain, the topography increases significantly, creating a steep slope that inclines east toward the Parliament Hill Viewpoint; this is presented in **Photograph 19**. At the base of the hill, there are several drains and a culvert to convey surface water toward the Hampstead pond chain; this is presented in **Photograph 20** and **Photograph 21**. During the site visit, there was evidence of leaves and debris build up near the drains and the area around the culvert was waterlogged; this suggests flows conveyed downslope are strong enough to transport material, whilst highlighting the potential for surface water ponding in this area.

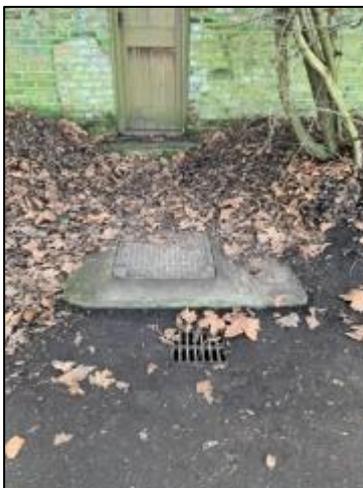
Photograph 22

At the base of the hill, a brick wall acts as a border between Hampstead Heath and private gardens of homes located on South Hill Park Gardens and South Hill Park; this is presented in **Photograph 22**. In the event of surface water ponding and high flow, there is potential for water to cross the wall threshold and underneath doorways, which could result in flooding of private properties located on South Hill Park Gardens and South Hill Park.

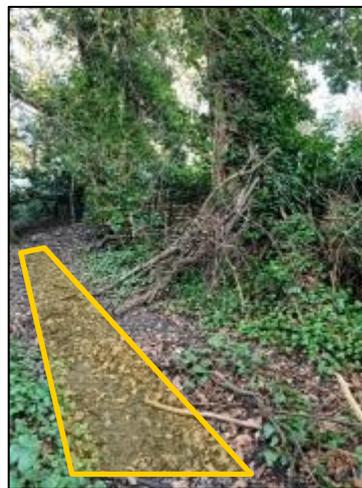
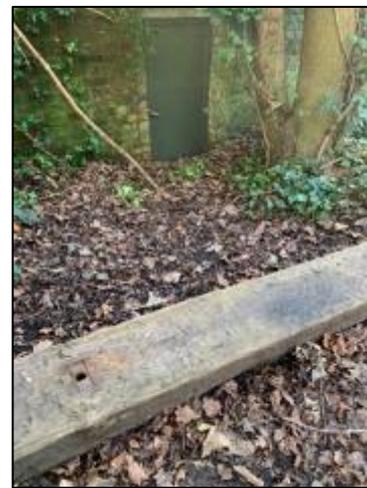
As presented in **Photograph 23** and **Photograph 24**, there is evidence of informal flood risk measures, such as use of timber and a railway sleeper, being used to direct flows away from the wall and doorways;

this suggests surface water flows conveyed downslope have impacted private property previously. It is important to note that this does not confirm the occurrence of internal flooding yet does indicate the presence of a pathway near the property boundary.

- Anecdotal evidence from local residents note a small stream was once conveyed water overland, behind the gardens of South Hill Park toward the Hampstead Number 2 Pond. This has since been replaced by a drain. Site observations of Hampstead Heath confirmed the likelihood of a flow pathway behind the wall of the gardens, due to informal flood prevention measures (**Photograph 23** and **Photograph 24**).

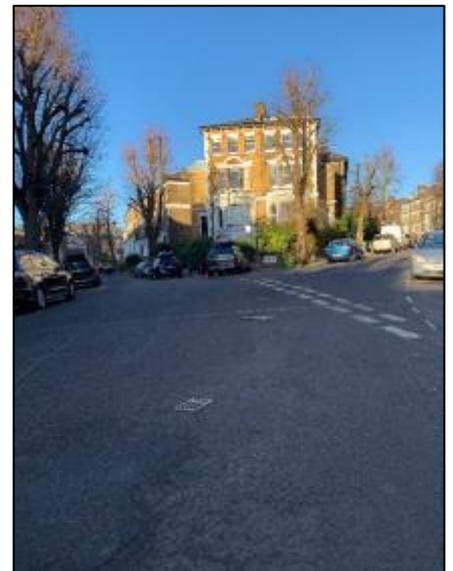
Photograph 27

As presented in **Photograph 26**, the allocated parking spaces border the road on both sides and the footpath is approximately 2m wide; the total impermeable area reduces capacity for infiltration, increasing the volume and rate of surface water flows. As presented in **Photograph 27**, South Hill Park Gardens meets at a midpoint on South Hill Park; this allows for the confluence of flows and contributes to the volume of surface water conveyed downslope.

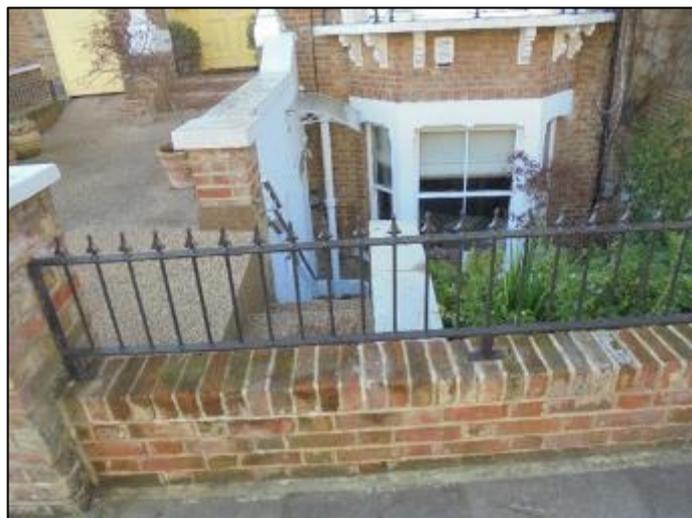
Photograph 28

Although a large proportion of the property thresholds and doorways are raised above road height, many of these buildings have a ground floor below the road level; this is presented in **Photograph 28**. Should surface water transfer to the footpath, the ground floor of a property may be susceptible to water ingress, as flows are conveyed to localised areas of low elevation.

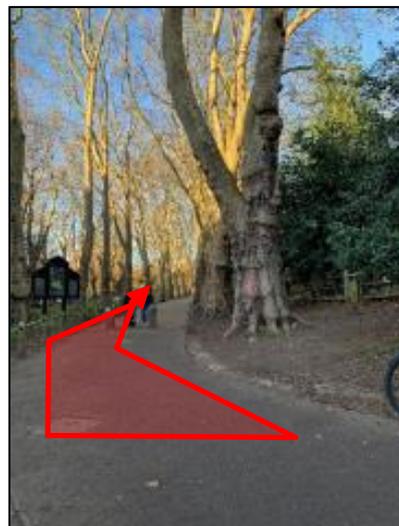
Photograph 34

Immediately east of South End Road, there is an area of greenspace which is approximately 35-50m in width. The greenspace inclines toward Hampstead Heath, creating a gradual slope to its entrance. As presented in **Photograph 34**, a footpath extends across the greenspace, ending at the junction of South End Road and South Hill Park. A surface water pathway is likely to emerge from this area, due to the slope and impermeable surface of the footpath, contributing to the volume of surface water conveyed to South End Road.

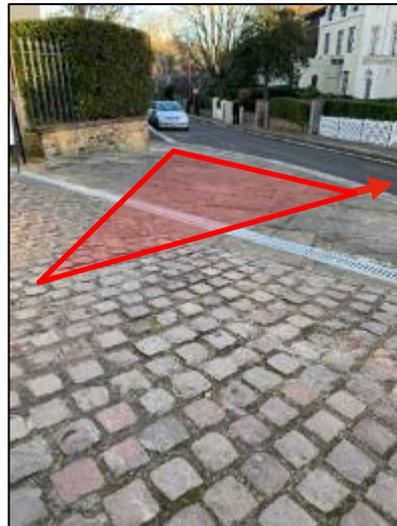
Photograph 36

At the junction of Downshire Hill the road and footpath curves toward Keats Grove, creating a decline in slope toward Keats Grove; as presented in **Photograph 36**. It is likely that higher volumes of surface water will be directed to Keats Grove. In addition, the kerb height of the footpath at the junction is level with the road, therefore surface water flows are expected to overspill onto the footpath.

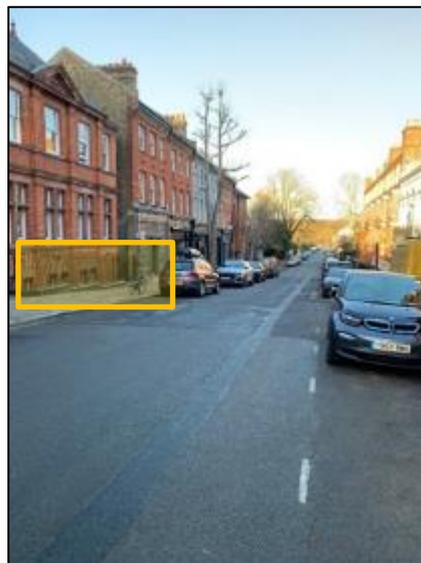
**Photograph 38**

The kerb height of Downshire Hill varies, yet typically raised  $\geq 100\text{mm}$  from road level. A large proportion of properties are set back  $\geq 3\text{m}$  from the road and are bordered by a wall, which may reduce the likelihood of water ingress in the event that flows exceed kerb height. Toward the south western sections of Downshire Hill, there are a small number of properties with a ground floor below road level; this is

presented in **Photograph 38**. These properties may be more susceptible to ingress in the event of water levels exceeding kerb height.

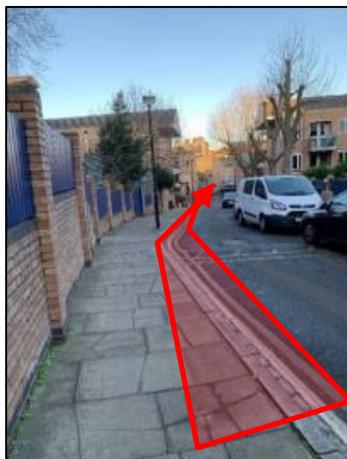
Photograph 41

Aspern Grove and Russell Place are located in an area of low elevation, relative to the areas of interest within the Heath Watershed hotspot. As presented in **Photograph 41**, Aspern Grove is characterised by a steep slope, which declines to the east. At the junction of Aspern Grove and the A502, the kerb has been dropped to road level. Surface water pathways conveyed via the A502 may overspill onto the footpath and continue downslope, toward Aspern Grove. As presented in **Photograph 42**, there are a number of small speed bumps located on the road, which may obstruct any surface water flows and could result in ponding.

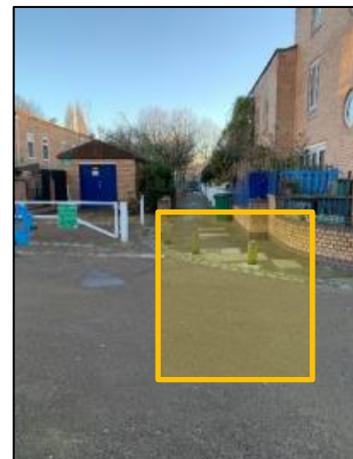
Photograph 43

Russell Place is situated off Aspern Grove, toward the base of the slope. As presented in **Photograph 43**, Russell Place is perpendicular to Aspern Grove. There is no kerb separating the roads, meaning the conveyance of surface water to Russell Place is unobstructed; in the event of ponding, surface water may approach property thresholds. However, the risk of water ingress is reduced as property thresholds at this location are raised approximately 200mm above road level.

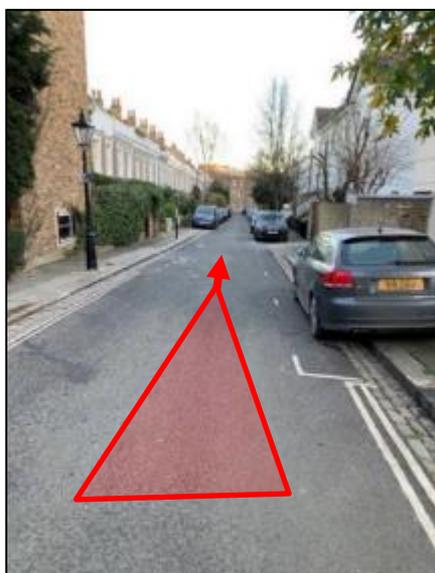
**Photograph 44**

As presented in **Photograph 44**, Quadrant Grove is a level road surface. Although there is a decline in slope to the east, the gradient is small and so is unlikely to convey large volumes of surface water to the east, such as Malden Road. Ponding is considered likely due to the level surface and low number of drains found on Quadrant Grove.

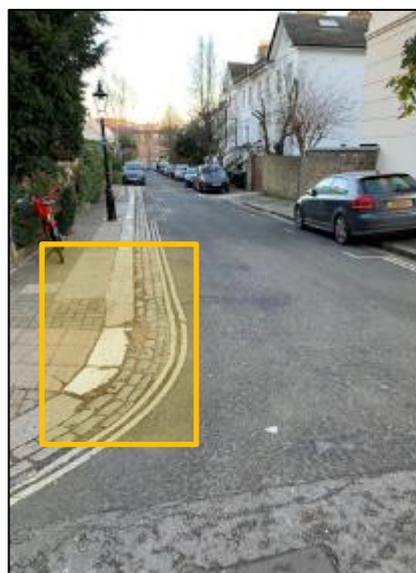
**Photograph 45**

The kerb height varies, with sections of the kerb at road level; this is presented in **Photograph 45**. At these locations, surface water is likely to transfer to the footpath. A large proportion of property thresholds are level with the kerb height, therefore there is potential for surface water to approach the threshold. However, several of the properties are bounded by a wall, which may act as a barrier and reduce risk.

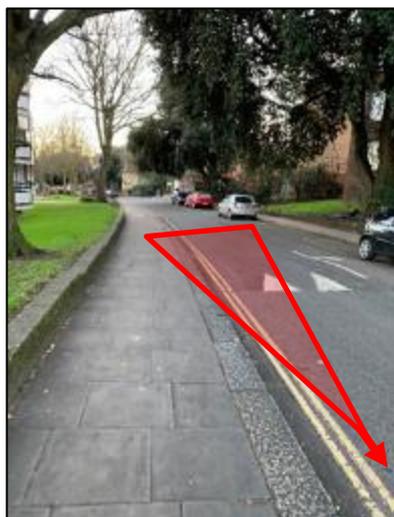
Photograph 46

As presented in **Photograph 46**, Maitland Park Villas is characterised by a gentle slope, which declines south. Although gradual, the elevation is significantly lower in the southern section of Maitland Park Villas, compared to the north; this is due to the length of the road, which extends over a large area. Flow pathways are likely to form, due to the decline in elevation and road length. Surface water is expected to be conveyed toward the Prince of Wales Road, located at the base of the slope.

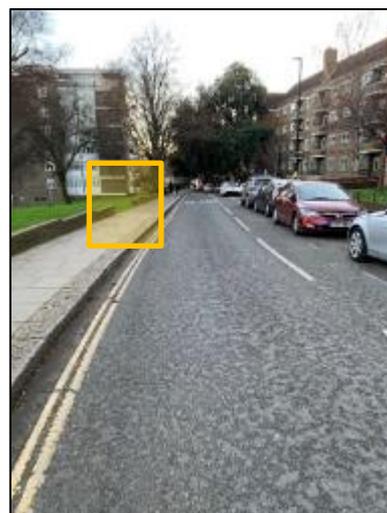
Photograph 47

East of Maitland Park Villas, an area of greenspace gently slopes to the east toward Maitland Park Road. The greenspace is bordered by a wall <500mm in height and small sections of the wall are removed, to allow for public access; this is presented in **Photograph 47**. at these locations, the surface

water on the footpath may be conveyed downslope, toward the Apartment Buildings which are located on Maitland Park Road.

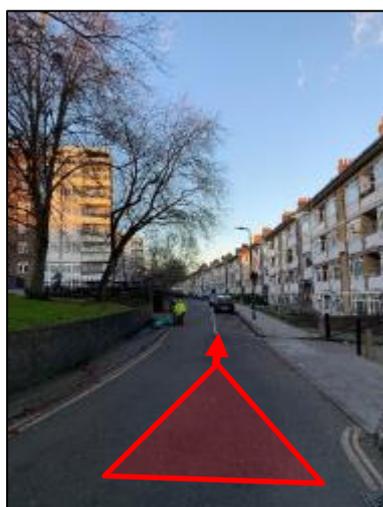
Photograph 48

As presented in **Photograph 48**, the slope Maitland Park Road gradually increases north, from the junction. For this reason, it is likely that surface water ponds at the junction or is conveyed immediately east, to the adjacent driveway. Several properties at this location are situated below the road level yet are set back approximately 5m from the road and separated by a wall or grass verge. This may act as an obstacle to flow, to reduce the likelihood of surface water approaching the property threshold.

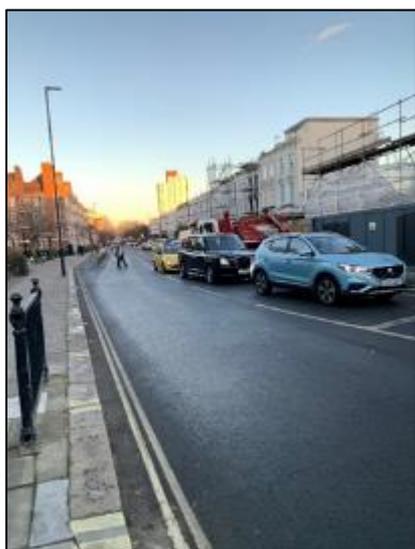
**Photograph 49**

As presented in **Photograph 49**, the surface of the Prince of Wales Road is level. The road is bordered by a cycle lane and footpath of approximately 3m on both sides, creating a large impermeable surface

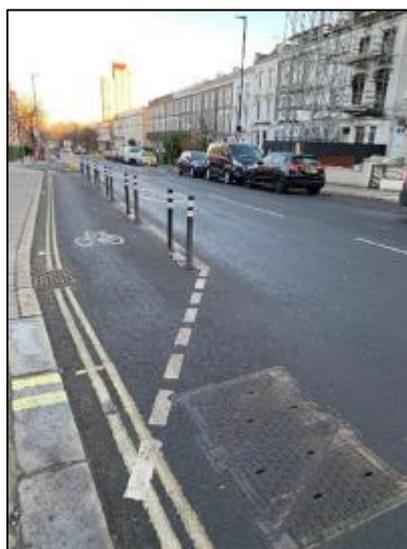
**Photograph 50**

area; this is presented in **Photograph 50**. The capacity for infiltration is therefore low and could result in surface water ponding on the road surface.

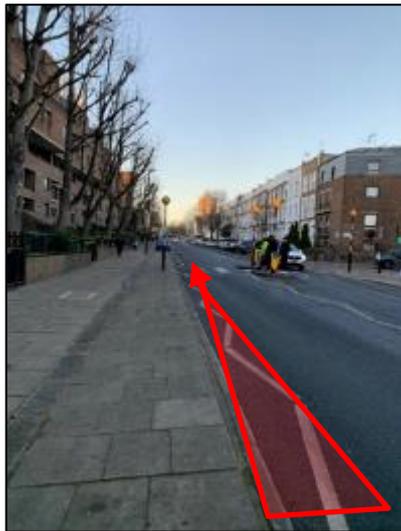
**Photograph 53**

As presented in **Photograph 53**, Malden Road is characterised by a gentle slope, which inclines to the north. Although gradual, the elevation is significantly lower to the south of Malden Road, compared to the northern sections of the road; this is due to the length of Malden Road, which extends over a large area. The steady decline in elevation and road length creates a direct surface water pathway to the base of the slope and the Prince of Wales Road.

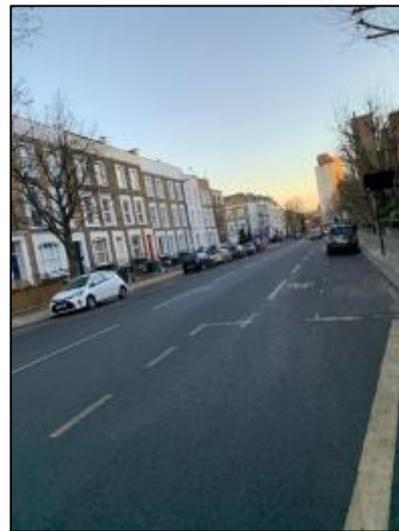
**Photograph 54**

presented in **Photograph 54**. This creates a large impermeable area, which reduces the capacity for infiltration and is expected to increase the volume of surface water conveyed downslope.

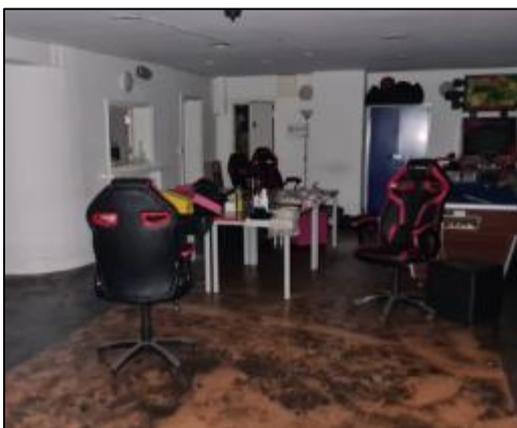
- As presented in **Photograph 57** and **Photograph 58**, The Winch Community Hub was subject to water ingress and resulted in damage to the facility, deposited silt and debris. News articles highlight the disruption caused by the flood on the 12<sup>th</sup> July event and imply the need for fundraising, in order to repair the level of damage;

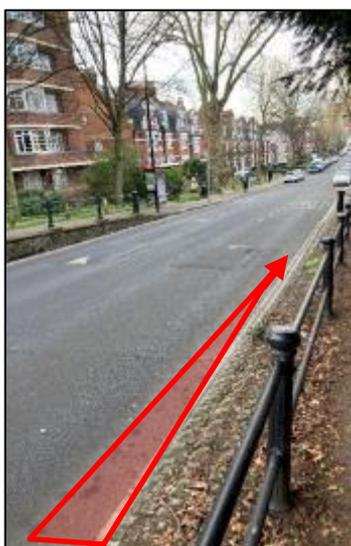
Photograph 59

Belsize Avenue is 500m in length and is one of the longest roads within the hotspot. As presented in **Photograph 59**, Belsize Avenue is characterised by a gentle slope, which facilitates the conveyance of flows south, toward roads situated within a low elevation; this includes Belsize Park and Buckland Crescent.

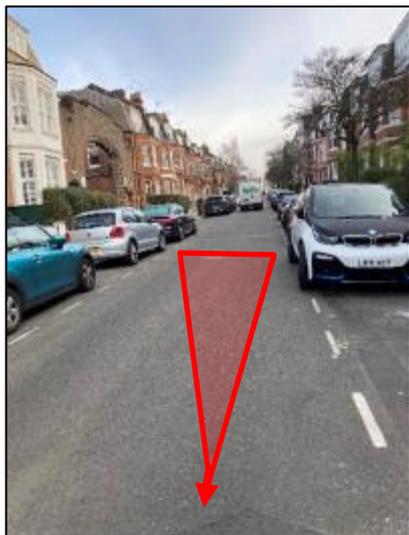
Photograph 61

As presented in **Photograph 61**, Glenloch Road has a steep slope which declines south west. The road provides an unobstructed, direct impermeable surface to the lower elevations of the road. This will increase the rate of surface water flows down Glenloch Road.

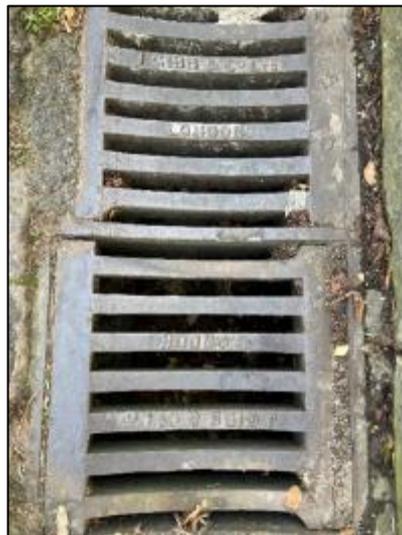
Photograph 62

At the time of the site visit, the drains at the base of the slope consisted of leaves and debris; the condition of the drains is presented in **Photograph 62**. This indicates surface water flows occur frequently or are strong enough to transport large volumes of debris downslope, increasing the risk of sewer surcharge.

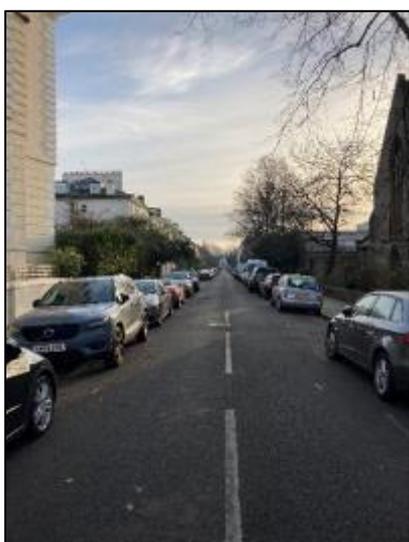
Photograph 63

As presented in **Photograph 63**, Belsize Square is a level road with no distinguishable slope and is situated in an area of low elevation relative to its surroundings. Belsize Park Gardens exhibits a similar topography, with no distinguishable slope.

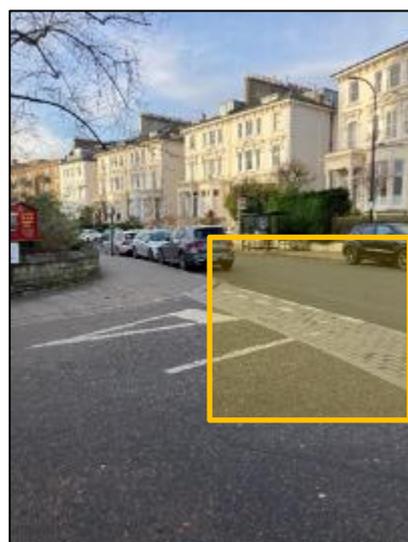
Photograph 64

Belsize Square and Belsize Park Gardens are located downslope of Belsize Avenue and may therefore be affected by flows. However, the junction of both Belsize Square and Belsize Park Gardens are raised by a road calming measure; this is presented in **Photograph 64**. The raised level acts as an obstruction to flow and reduces the likelihood of ponding. Transfer of surface water across the road calming measure is possible during high flow.

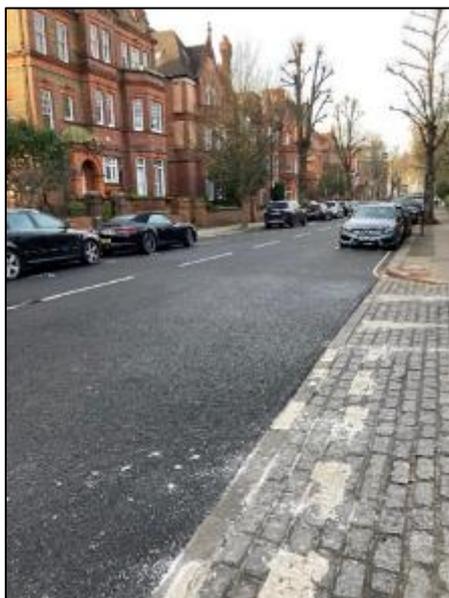
**Photograph 65**

As presented in **Photograph 65**, Eton Avenue provides a level terrain with no distinguishable slope. For this reason, the emergence of a surface water pathway on Eton Avenue is considered unlikely.

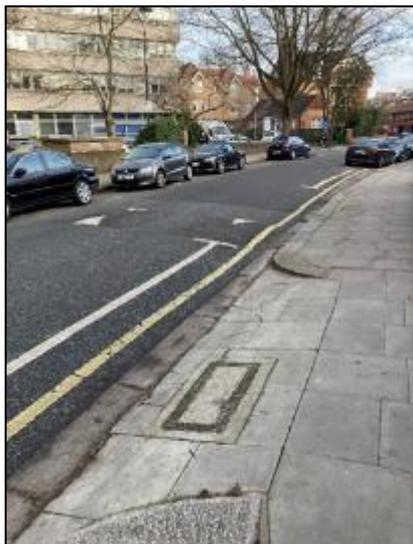
Photograph 66

Belsize Lane is one of the longest roads within the Belsize Park Swiss Cottage hotspot, extending from Haverstock Hill in the east, to Fitzjohn's Avenue in the west. The slope of the road varies greatly between the western and eastern sections of the road. As presented in **Photograph 66**, there is no distinguishable slope in the western and central sections of Belsize Lane. In contrast, the eastern section of the road, at the junction of Belsize Lane and Ornan Road, is characterised by a steep slope rising north, to meet Haverstock Hill.

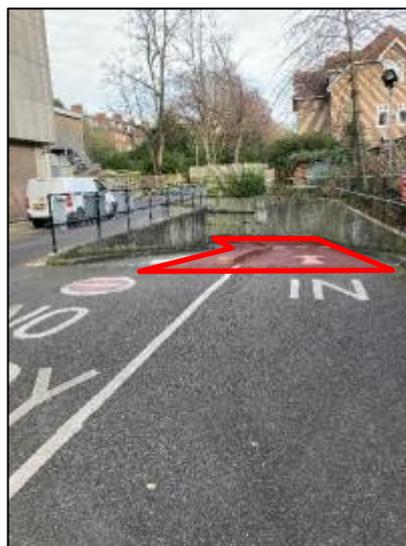
Photograph 67

The Tavistock and Portman NHS Foundation Trust is adjacent to the junction of Fitzjohn's Avenue and Belsize Lane. Although a large proportion of the site is raised above road level, an access point to the rear of the building is provided via a steep slope; as presented in **Photograph 67**. Should surface water pond on site, or transfer from Belsize Lane, surface water will be conveyed downslope and could impact the rear of the building. It was not possible to access this area, as it is located on private property.

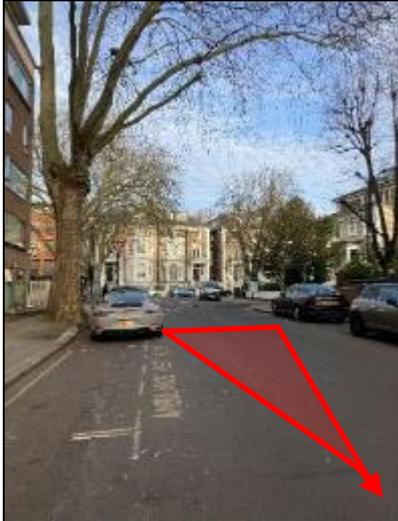
Photograph 68

Winchester Road is characterised by a steep slope which declines south, toward Adelaide Road (B509); this is presented in **Photograph 68**. The road is straight and wide, due to the width of the carriageway and roadside parking. Winchester Road therefore provides a direct, impermeable surface toward the lower elevations; this is likely to increase the rate and volume of surface water conveyed downslope, which could increase risk of exceeded sewer drainage capacity.

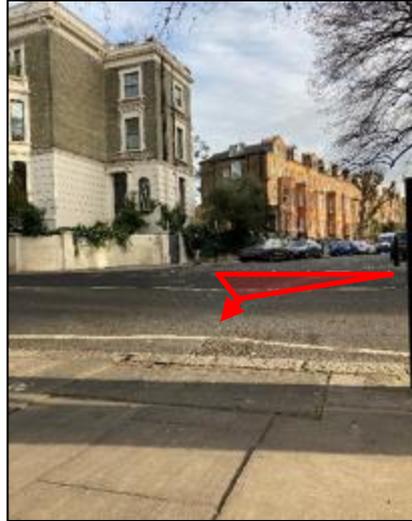
Photograph 69

The Fellows Road junction is located at the mid-point of Winchester Road. As presented in **Photograph 69**, Fellows Road gradually declines in slope toward the junction; this is likely to contribute to surface water flows on Winchester Road.

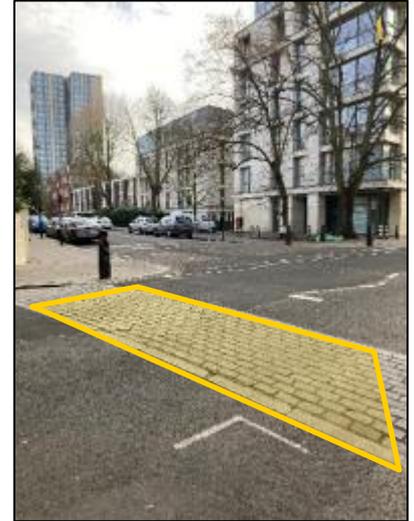
Photograph 70

At the junction, the road surface is slightly raised due to the design of a road calming measure; this is presented in **Photograph 70**. The measure is likely to obstruct or slow flows, resulting in ponding at this location. As indicated in **Photograph 71**, the kerb heights at this location are equal to road level, facilitating the transfer of surface water to the footpaths and toward nearby properties, increasing the risk of water ingress.

The road surface at the junction undulates, creating an uneven terrain which declines west, toward the footpath and property; as presented in **Photograph 70**. The slope, condition of the road surface and kerb height, are highly likely to result in the accumulation of surface water at this location and the conveyance of flows toward properties on the western side of Winchester Road.

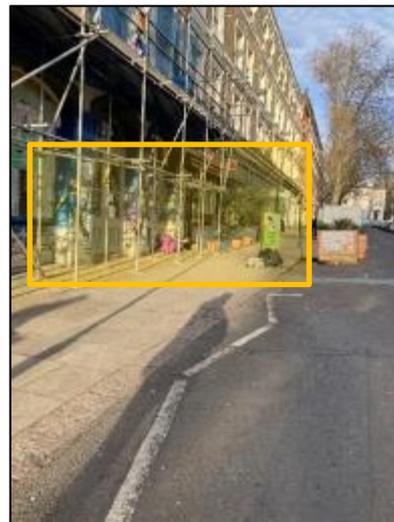
Photograph 72

As presented in **Photograph 72**, there are several commercial properties located west of the junction of Fellows Road, including The Winch Community Hub. The threshold of these properties reaches approximately 100mm. Although the threshold is raised above road level and may offer a level of protection against water ingress, the risk of water ingress is high due to the kerb height and road surface, which declines to the footpath.

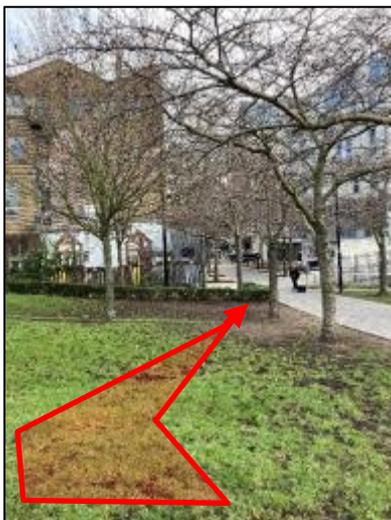
Photograph 73

Behind the properties on Winchester Road, there is an area of landscaped greenspace. As presented in **Photograph 73**, the greenspace has a gradual slope which declines east toward the rear entrance of properties on Winchester Road. There is a wide footpath from the greenspace to Winchester Road, that borders the western boundary of The Winch; as presented in **Photograph 74**. The footpath provides an impermeable surface, to convey surface water downslope, from the greenspace toward Winchester Road. This creates an additional pathway, increasing the volume of surface water conveyed toward Winchester Road, thus increasing the risk of flooding and exceeded sewer drainage capacity.

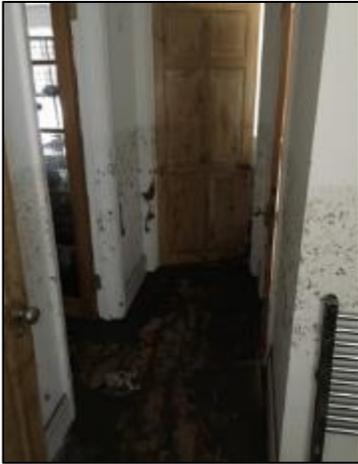
Photograph 75

- Internal flooding was observed on the 12<sup>th</sup> July, affecting several properties on Belsize Road. As presented in **Photograph 75** the water level was observed to reach approximately 1m above ground level in one of the properties affected;

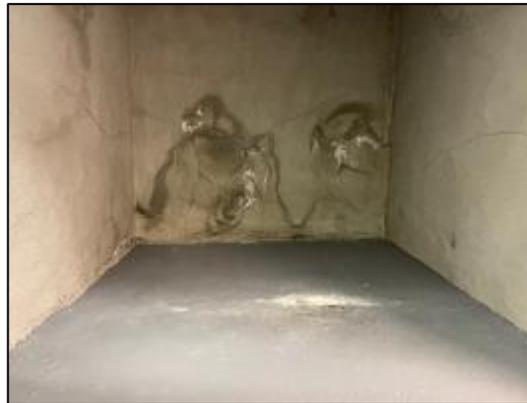
Photograph 80

- Anecdotal evidence indicates long term water damage to basement walls of properties located on Goldhurst Terrace; **Photograph 80** presents the water damage to a basement wall, six months after the 12<sup>th</sup> July event.

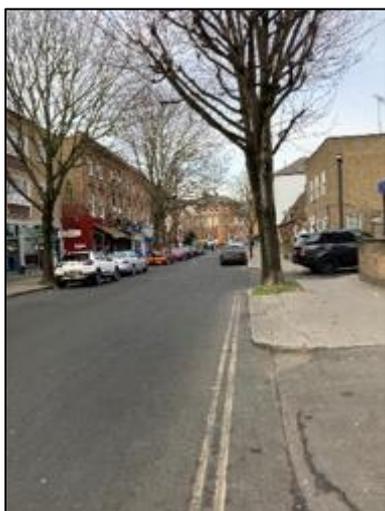
**Photograph 85**

The northern section of Fairhazel Gardens is characterised by a steep slope, which declines south to the junction of Goldhurst Terrace. South of the junction, there is no distinguishable slope of Fairhazel Gardens; as presented in **Photograph 85**. This results in the accumulation of surface water at the junction and may result in ponding on the southern sections of the road surface.

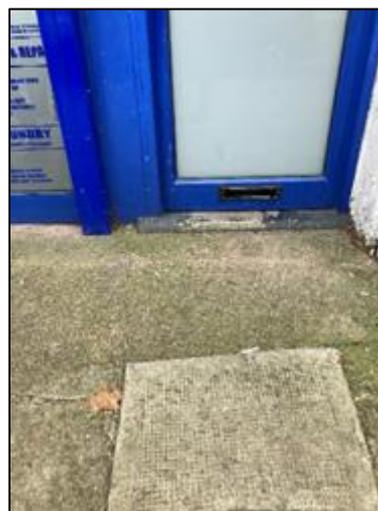
**Photograph 86**

There are several commercial properties located south of Fairhazel Gardens. The threshold of properties at this location are typically equal to the footpath; an example of this is presented in **Photograph 86**. Should surface water transfer to the footpath, the properties are susceptible to water ingress due to the low threshold.

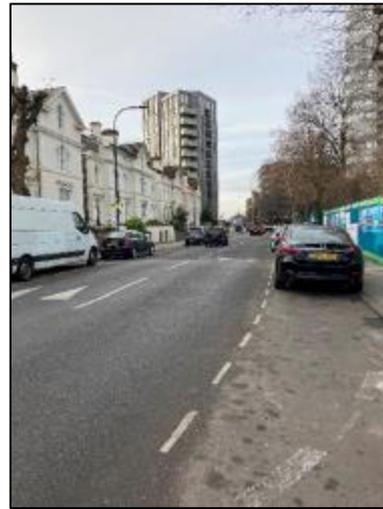
Photograph 88

The wide carriageway is bordered by a footpath on both sides, which ranges in width between 1m – 4m. In addition to this, eastern sections of Belsize Road are bordered by parking spaces; this is presented in **Photograph 88**. This creates a large impermeable surface area and reduces capacity for infiltration, increasing the volume of surface water conveyed downslope. A park is situated north of Belsize Road and may offer the potential for infiltration. However, the size of the greenspace is small relative to the surroundings, thus will provide little benefit the reduction of surface water volume or flow rate.

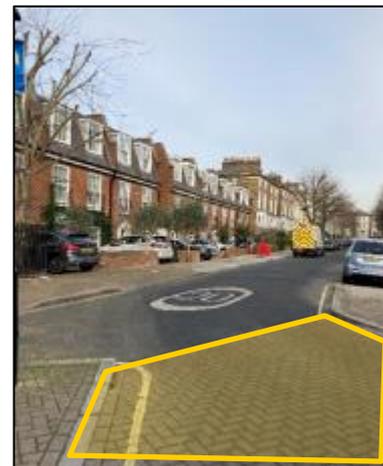
Photograph 90

As presented in **Photograph 90**, a speed bump is situated at the junction of Priory Terrace and Belsize Road, at the base of the slope. This may obstruct flows and could lead to ponding and/or surcharge of assets at this location, in the event of exceeded sewer drainage capacity.

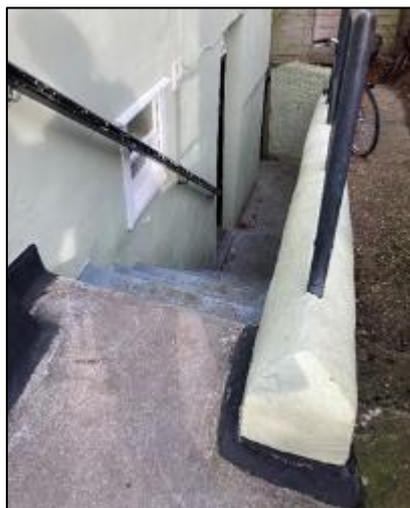
Photograph 91

Priory Road is situated west of Priory Terrace and exhibits a similar topography, with a steep slope that declines toward Belsize Road. A large number of properties on Priory Terrace have a ground floor located below road level, which increases the risk of flooding in the event of overspill onto the footpath. Properties located at the base of Priory Road and Belsize Road are at greatest risk, due to the conveyance of surface water to the lower elevations. An example of a ground floor apartment set 2m below ground level is presented in **Photograph 91**.

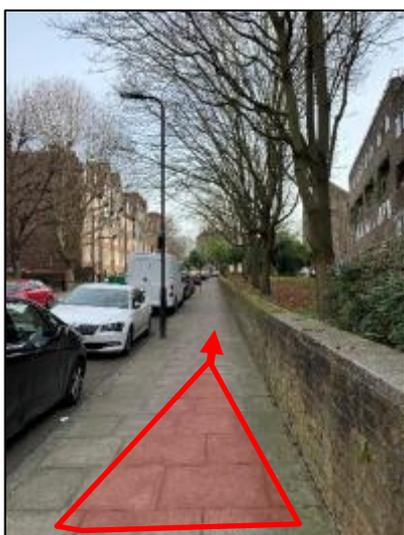
Photograph 92

Mortimer Place has a gentle slope which inclines west, toward the junction of Mortimer Crescent; this is presented in **Photograph 92**. Mortimer Crescent has a gentle slope which peaks at the junction; the northern and southern section of Mortimer Crescent gradually declines from the peak and toward Greville Road.

The slope of both Mortimer Place and Mortimer Crescent is likely increase the rate and volume of surface water conveyed on the road surface. A solid wall outlines the grounds of the apartment buildings which face onto the road, providing a barrier to flow and a level of protection against water ingress.

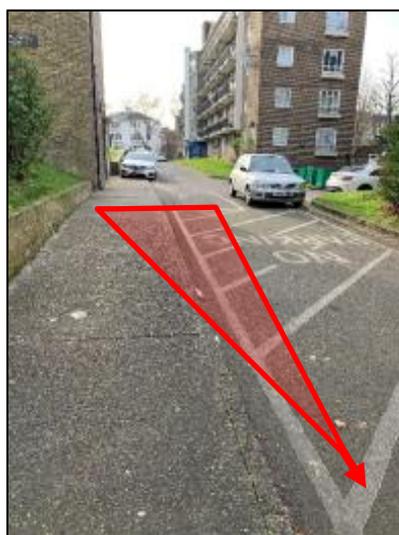
Photograph 93

As presented in **Photograph 93**, an access road is situated between the apartment buildings; this is characterised by a steep slope, which declines north toward Mortimer Place. Although the access road may increase the risk to nearby properties, due to its proximity, the ground floor apartments are bordered by greenspace which offers the capacity for infiltration. This may slow any emerging flows, thus reducing the risk of water ingress.

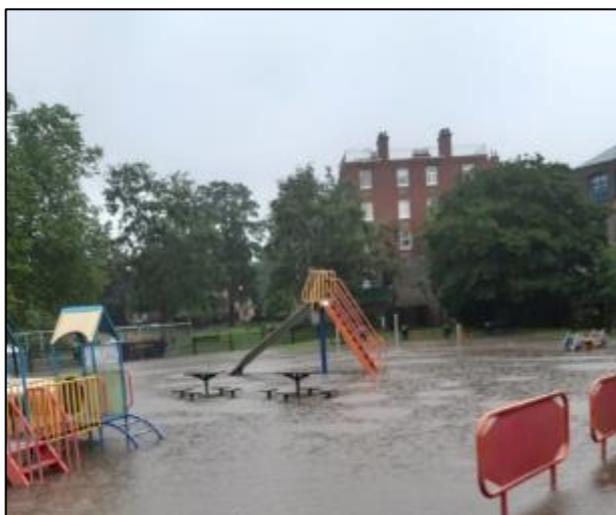
**Photograph 94**

It was observed from the site visit that the playground and Attendant's Building is situated within a localised area of low elevation, at the base of several small slopes found within the within the Kilburn Grange Park greenspace. Surface water flows are likely to be conveyed to the low elevation and accumulate on the playground, which is partly formed of impermeable material. There are no incident records to indicate the neighbouring Primary School flooded on the 12<sup>th</sup> or 25<sup>th</sup> July 2021.
